APPLICATION OF THE METHOD OF ACTIVE THERMOGRAPHY IN WOODEN STRUCTURES OF NINETEENTH CENTURY BUILDINGS

^{1,*}Silva, L.C.S.L., ²Mantilla, J.N.R. and ³Carrasco E.V.M.

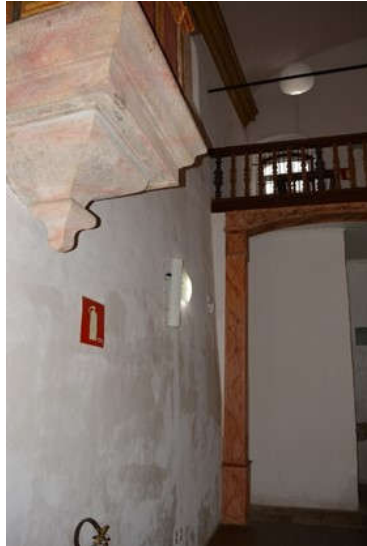
Figure 2. Deformation in the masonry resulted from the displacement of the armed rafter shear in the São José church in the city of Ouro Preto – Brazil

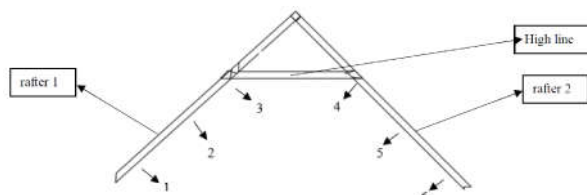
Figure 5. Selected areas of the armed rafter shears for thermographic damage mapping.

With the mapping (Fig. 5), the quantitative active thermographic method was applied to six areas that, by preliminary inspection, presented damages of both biotic and abiotic origin. It is noted that the geometric survey is of paramount importance in case studies to be quantified and localized the extent of the degraded area. With the data of the black body test, the thermal camera was calibrated for the tests with the following data:

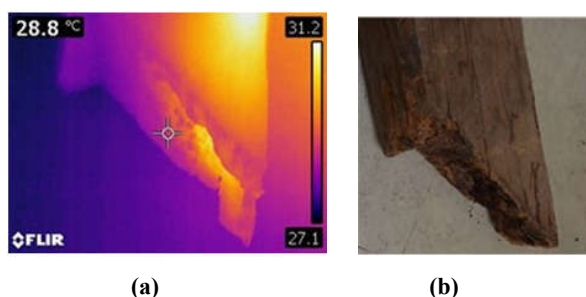
Figure 6. Area 1. Lower linkage of frame 1. (a) thermography, (b) connection detailing

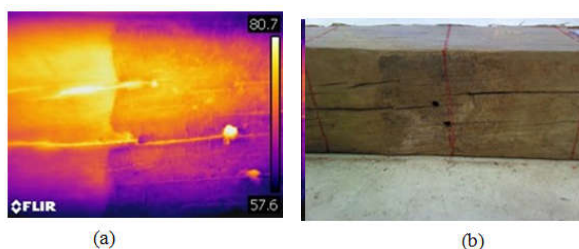
Area 2.

Figure 7. Area 2: (a) thermographic image, (b) part image

In the visual inspection, it was detected that area 2 (Fig. 7) presented on the surface biotic attack of fungi of brown rot, which caused the alteration in the heat absorption by the material and variable thermal amplitude in the same face tested. Region 3 (Fig. 8) presented a higher temperature range than all the other regions tested, reaching 82.5°C in the hottest areas and 27.1° C in the calibration temperature areas. This is due to the internal heating of the connection between the rafter 1 and the high line, notch region of the parts, and the loss of internal mass and heating of the metal locking elements. It was verified through the visual inspections that in regions 4, 5 and 6 there is presence of fungi of brown rot, causing the wood to decay. Thus, the thermographic test evaluated the depth of the damage in the internal region of the piece and, as can be seen in Figs. 9, 10 and 11, there is loss of internal material mass and fiber discontinuity. In region 5 (Fig. 10) it is still possible to identify an already dead xylophagous insect. Note that the constancy in the distance between the camera and the material to be tested is of fundamental importance, since the variation of the same increases the amplitude of the color scale. In the regions where there were the highest temperature amplitudes (Fig. 8 and 9) variation in the display color scale was observed with respect to the initial calibration temperature of the chamber due to the distance of the camera from the material. This does not invalidate the method but increases the color spectrum for heating other materials in the environment.

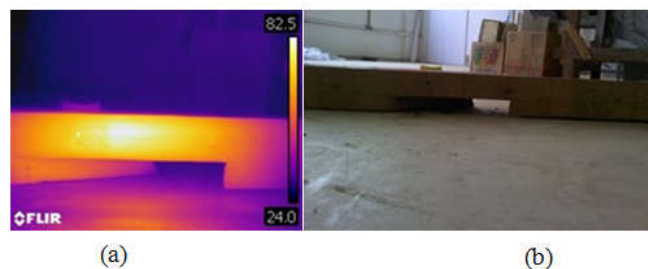
Figure 8. Area 3. (a) thermographic image, (b) part image

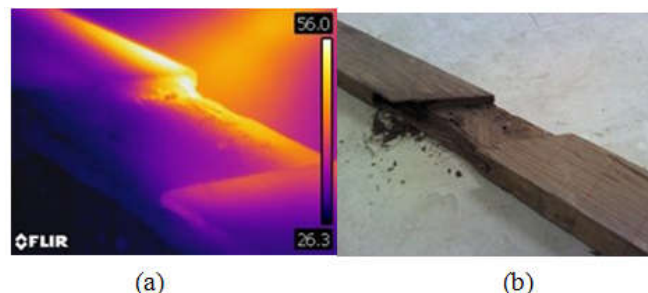
Figure 9. Area 4. (a) thermographic image, (b) part image.

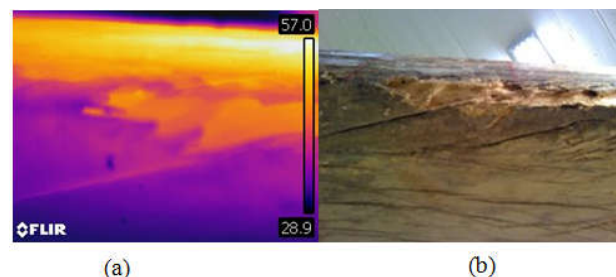
Figure 10. Area 5. (a) thermographic image, (b) part image.

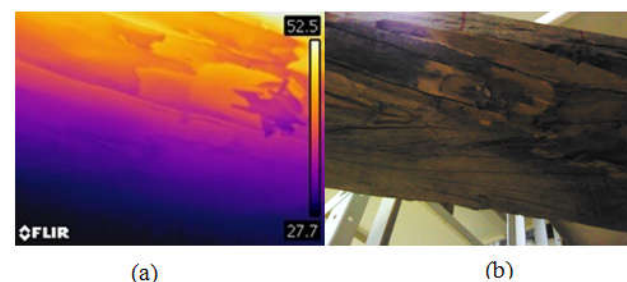
Area 6.

Figure 11. Area 6: (a) Thermographic image, (b) part image.
