International Journal of Development Research

Vol. 10, Issue, 06, pp. 36260-36266, June, 2020

INFRASTRUCTURE CAUSES OF ROAD ACCIDENTS ON THE YAOUNDE – DOUALA HIGHWAY, CAMEROON

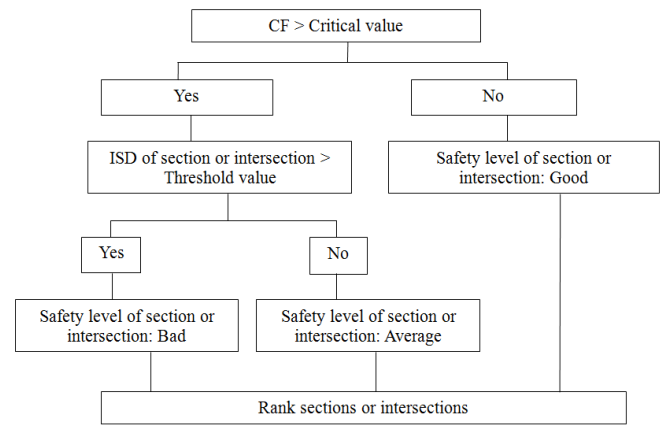
Figure 1. Flow chart for ranking of accident-prone locations

- This data was analysed using the crash frequency and injury severity density criteria and the road sections or intersections categorized following the steps in the flow chart in Figure 1;

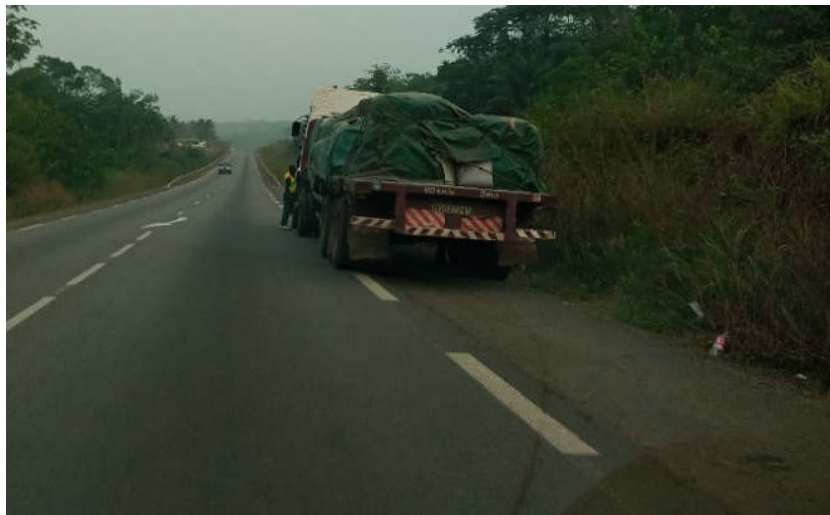
Figure 3. Parked vehicle by the roadside occupying part of the vehicle lane since shoulder width is insufficient

Shoulder width and absence of clear zone: No clear zone is present and the shoulder width of 2.4 m is not convenient to accommodate breakdown vehicles such as trucks by the roadside (Figure 3).

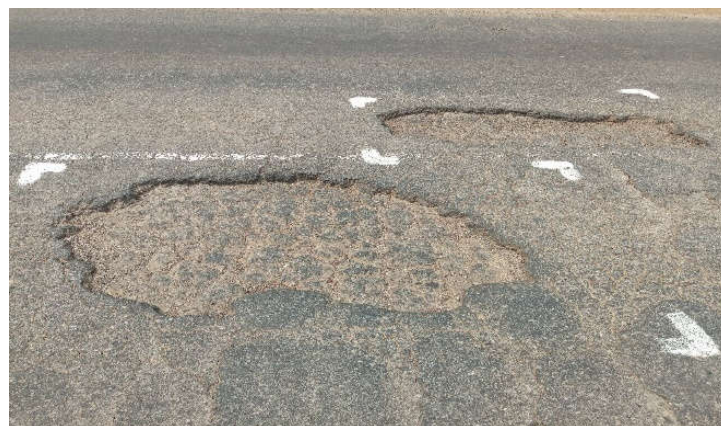
Figure 4. Delaminated road surface

State of road surface: The road surface is cracked, rutted and delaminated (Figure 4) which leads to hazards such as water collection on the road. This increases the risk of aquaplaning and leads to drivers performing manoeuvres to avoid damaged areas by moving to the lane reserved for the opposing traffic which might be a cause of head-on collisions.
