ENVIRONMENTAL IMPACTS OF THE URBANIZATION AND INTENSE PRECIPITATION IN THE SHARP IGARAPÉ IN MANAUS

ABSTRACT

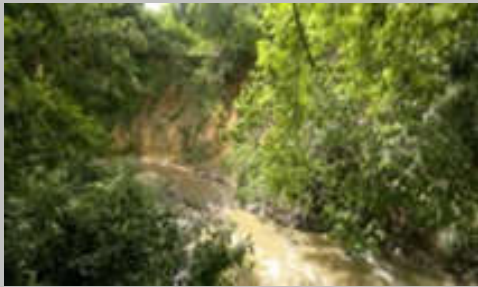
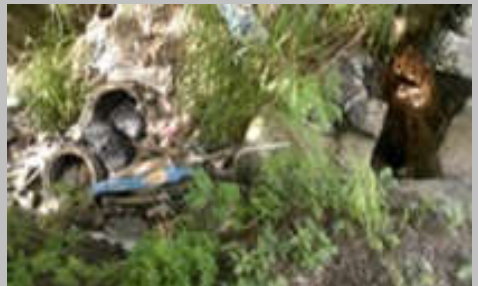
<p>Views on the right side of the Grande Circular Avenue</p>

Specification	GeographicCoordinate	Visual Memory
<p>Igarapé –1</p> <p>P-1</p> <p>Point located downstream of Av. Grande Circular.</p> <p>The vegetation is native, that is, without interference of the man.</p> <p>At this point, it is observed, a work of art, that leads the water course under the Av. Grande Circular.</p> <p>A large quantity of garbage is observed in the bed of the igarapé and the discharge of untreated sewage.</p>	<p>3° 5'37.41"S 59°56'53.32"W</p>

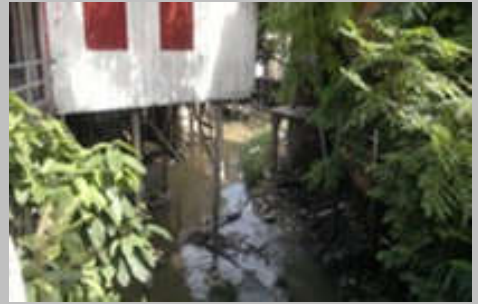
<p>View from the left side Grande Circular Avenue</p>
<p>P-2</p> <p>Balneário, located upstream of the project area.</p> <p>It is abandoned.</p>	<p>3° 5' 39.05"S 59°56' 8.88"W</p>

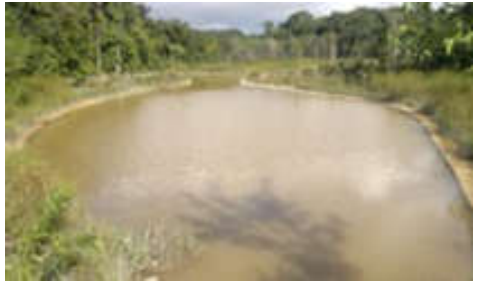
<p>P-3</p> <p>At this point the igarapé 1 has a width of 1,20m, and a depth of 0.20m.</p> <p>It is silted, that is, the sand is obstructing the passage of the stream.</p> <p>It has native vegetation, odor of sewage.</p> <p>It has microdrain piping thrown in its bed. It crosses the Av. Itacolomi with two pipes of Φ1000mm.</p>	<p>3° 5' 40.14"S 59°56' 17.05"W</p>

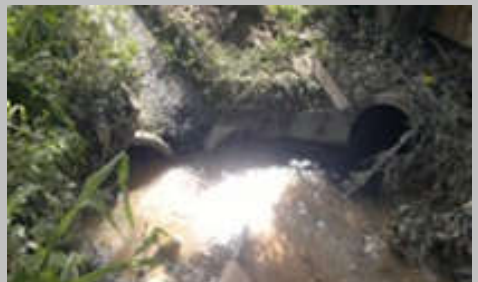
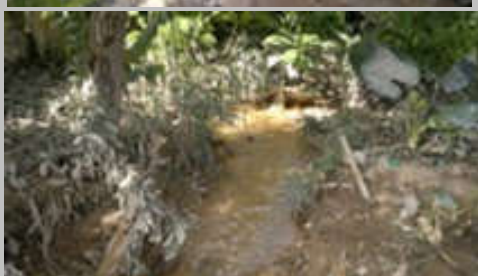
<p>P-4</p> <p>It has the width of 1.5 meters, and depth of 0.30 meters.</p> <p>It has native vegetation and we have residences located on the stream.</p> <p>Residents reported that when heavy precipitation occurs the lower houses are submerged, as are the access bridges of the residents.</p>	<p>5 - 3° 5' 37.259"S 59°56' 31.122"W</p>

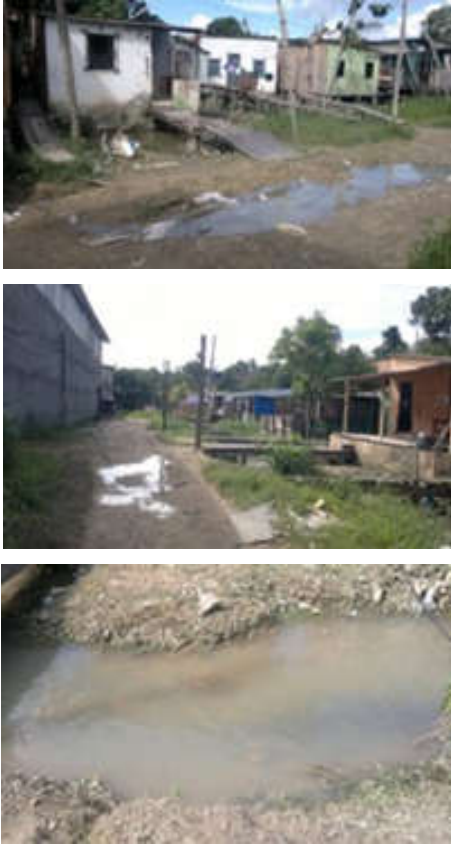
<p>P-5</p> <p>It has a width of 2.00 m and a depth of 0.8 m.</p> <p>It presents a native vegetation and we do not have residences located on the igarapé.</p>	<p>6 - 3° 5' 38.59"S 59°56' 26.70"W</p>

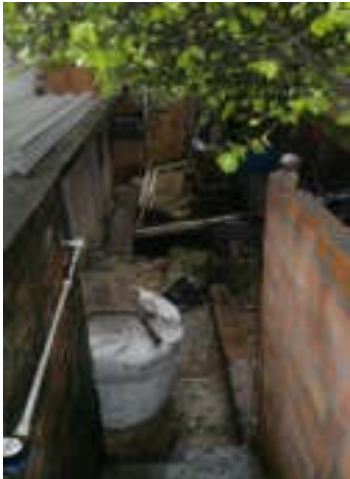
<p>P-8</p> <p>At this point the Igarapé 3 is channeled through 1200mm tubing that leads the same under Av. Itacolomi.</p> <p>In the area there is a large presence of dwellings, making it impossible to access the igarapé 3.</p>	<p>3° 5' 31.77"S 59°56' 28.02"W</p>

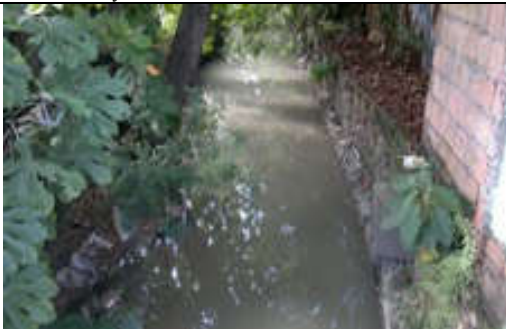
<p>View from the left side of Multibrás Street</p>

Specification	Geographic Coordinate	Visual Memory
<p>Igarapé - 4 P-9</p> <p>The Igarapé 4 has its natural shape changed by infrastructure. It has gabion side walls. Its width of 4 meters, and depth not verified.</p> <p>It shows the arrival of pipes and drainage and a native vegetation and we do not have residences located on the igarapé.</p>	<p>3° 5'43.75"S 59°56'38.79"W</p>

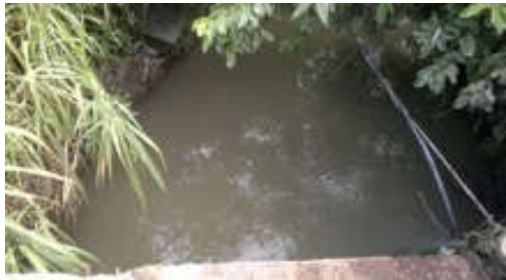
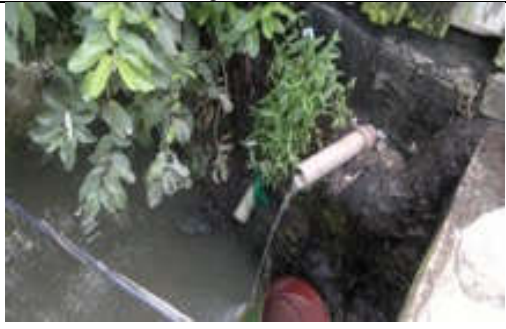
<p>View from the right side of Multibrás Street</p>
<p>P-9</p> <p>There is a large amount of sewage disposal in commercial premises and homes.</p>	<p>3° 5'43.75"S 59°56'38.79"W</p>
