International Journal of Development Research

RESEARCH ARTICLE

THE CAUSES OF COLLAPSE OF RETAINING STRUCTURES: A CASE STUDY OF A RETAINING WALL AT ALPHAVILLE IN NOVA LIMA MINAS GERAIS

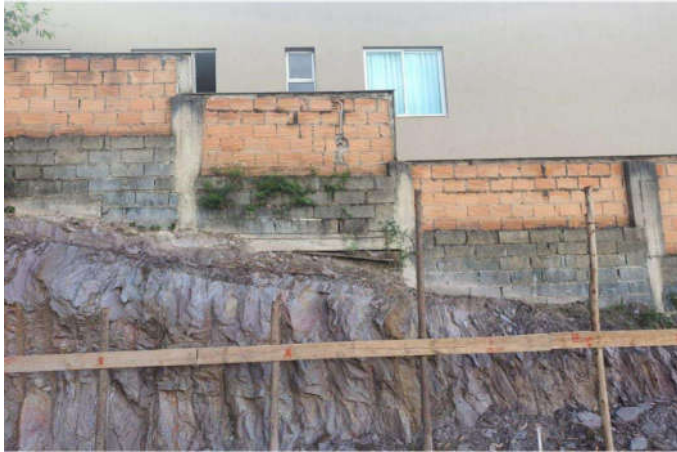
Figure 1. Retaining Wall

With the heavy rainfall that occurred on Christmas Eve in 2020, several slopes and slopes were at imminent risk of ruin. Furthermore, with the lack of preliminary studies, problems can occur in containment structures, as was the case with the Retaining Wall

(Figure 1) in Condomínio Vargem das Flores in Alphaville in Nova Lima, which collapsed on the 25th 11/2020.

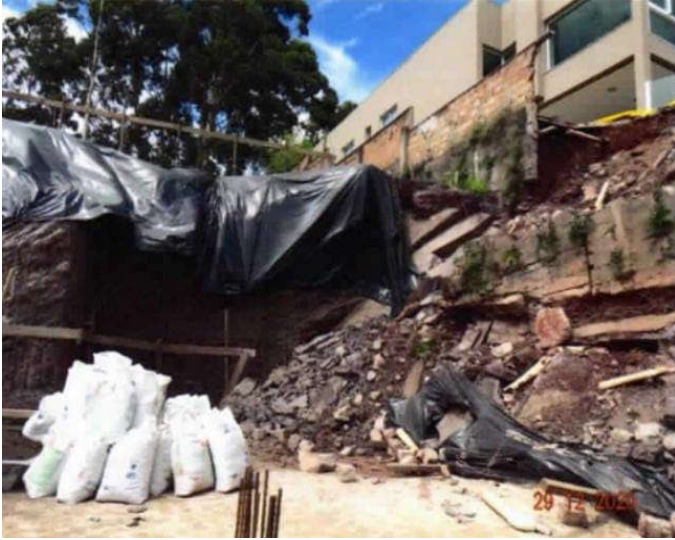
Figure 5. Cutting height

A fact observed in loco, culminating in the collapse, is that the sectional platform carried out in the work by the neighbor shows the significant cutting height of the land, far below the base line of the boundary wall of the owner's property above (Figure 5). The lack of drainage after the earthworks caused the mass of earth to percolate along with the water between the wall and the foundation. Since the soil is also of a silty character (as observed in loco), it presents a small water percolation, causing the water to remain "stored" in the earth mass for a longer period of time, which causes an increase in the active force on the wall. As a result, with the earthwork to the right of

the wall, the passive effort of the wall was reduced, causing the wall to be out of balance and more prone to collapse.

Due to this natural characteristic of balance, the works of alteration of soil mass profiles (earthwork in cuts and embankments) must be carefully designed, supported by technical procedures and common sense, seeking to harmonize the interference of man with balance required by nature. Imperiously, the execution of this type of work must be monitored by the responsible technical engineer in all its phases (design and execution), ensuring compliance with the project or, in cases where the field is difficult, an adaptation that is in line with current technical standards and the constructive techniques. In conjunction with the earthworks, the solutions for containment of cuts and embankments must be preceded by projects prepared by duly qualified technicians and their execution also accompanied by a qualified professional.
