APPLICATION OF THE METHOD OF ACTIVE THERMOGRAPHY IN WOODEN STRUCTURES OF NINETEENTH CENTURY BUILDINGS

^{1,*}Silva, L.C.S.L., ²Mantilla, J.N.R. and ³Carrasco E.V.M.

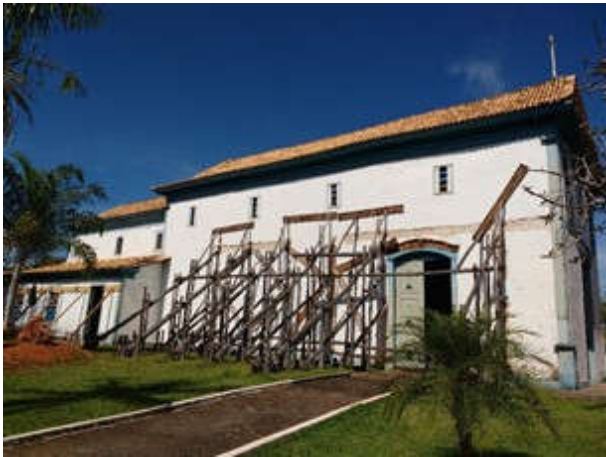
Figure 3. View of the left side facade of the Matriz do Santíssimo Sacramento church. City of Jequitibá, Minas Gerais, Brazil

State of Conservation of the armed rafter shears of the Matriz do Santíssimo Sacramento church: With visual inspection, it was found that the state of conservation of the shears of church's coverage are critical. Through in situ inspection it was verified that there were fractures in the shingles, infestation of xylophagous insects, vegetation, pigeons and rodents. Among all the anomalies, the most prominent was the pathology of structural order, resulting from a displacement caused by horizontal thrust, characteristic of the armed rafter shears, which caused large deformations in the church's masonry. With such a situation of risk of collapse, safety measures were adopted, such as external shoring of masonry (Fig. 3). The wooden pieces of the shears analyzed were assigned by the company SEPRES, and the gather of these pieces was authorized by IEPHA/MG (Fig. 3) and transported to the Laboratory of Technological Research (LPT) of the School of Architecture of the Federal University of Minas Gerais.
